Manhole Inspection Summary

Manhole # S43Y__002MH

Location Address: **behind school at 1400 block E Fort Av** Cross Street: **Decatur Street**

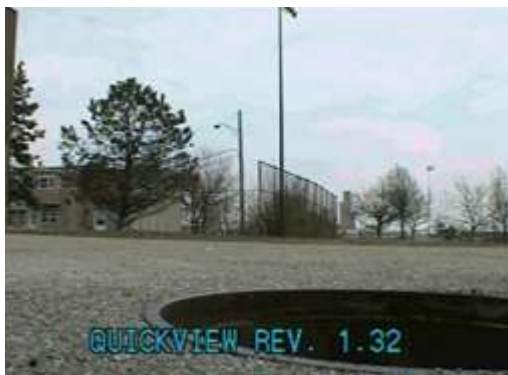
Location View

Comments **Located in paved play yard behind school**

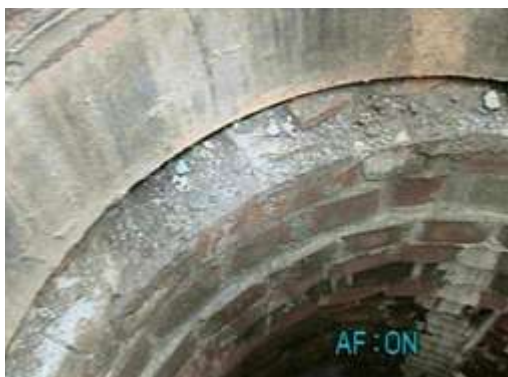
Defect 3

Frame Offset: **2** (in.) Condition: ☒ Sound ☐ Cracked ☐ Leaks

Condition: ☐ Sound ☐ Cracked ☐ Root Intrusion ☐ Loose Brick ☒ **Deteriorated**

frame offset, deteriorated adjustment

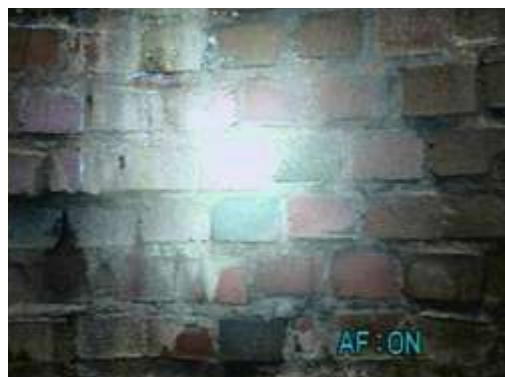
Defect 2

Infiltration: ☐ None ☐ Joint ☐ Cracks ☐ Mortar ☐ Roots ☒ **Wall**

barrel wall infiltration

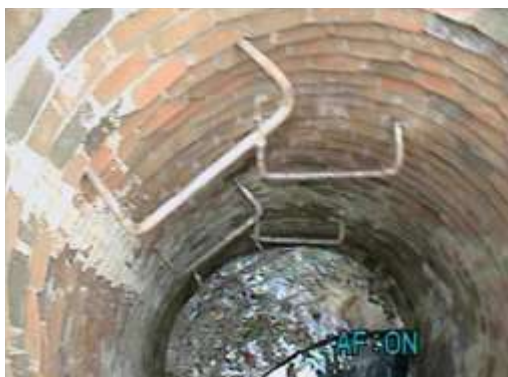
Defect 1

Condition: ☐ Sound ☐ Cracked ☐ Root Intrusion ☐ Deteriorated ☐ Leaks ☒ **Debris**

Steps Count: **5** Missing: **0** ☒ **Corroded**

corroded steps, bench debris

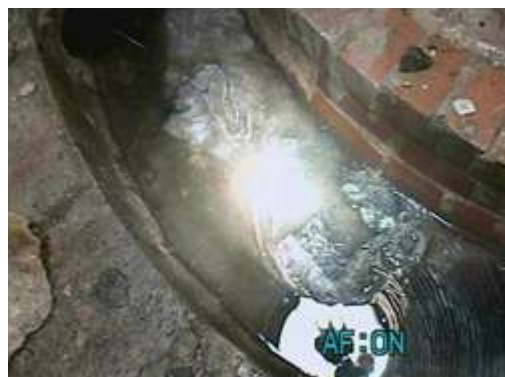
Defect 4

Condition: ☐ Sound ☐ Cracked ☐ Root Intrusion ☐ Deteriorated ☐ Leaks ☒ **Debris**

channel debris

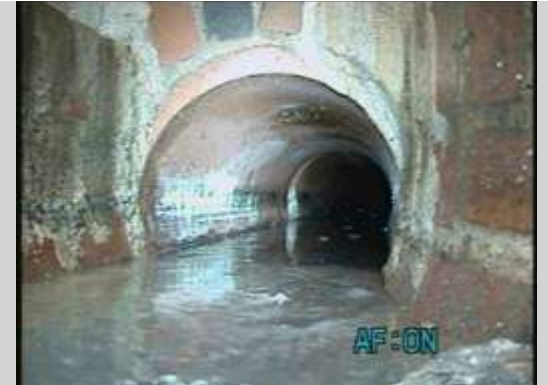
12 O'Clock Outflow

12 in. Circular Gravity Sewer
Pipe Out @ 12 O'Clock

Invert Depth: **10.88** (ft.) Flow Characteristics: **Slow**

Infiltration: **None** Pipe Seal Cond: **Unknown**

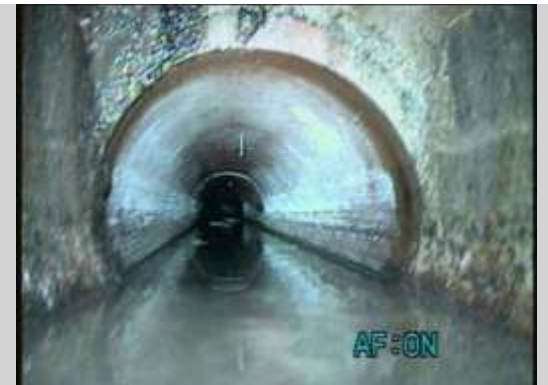
4 O'Clock Inflow

12 in. Circular Gravity Sewer
Pipe In @ 4 O'Clock

Invert Depth: **10.85** (ft.) Flow Characteristics: **Slow**

Infiltration: **None** Pipe Seal Cond: **Unknown**
